# Material Characterization of Diesel Engine Connecting Rod Excavator 6 Cylinder 350 HP

**Abstract** - Component failures in heavy equipment engines can cause significant operational losses, particularly in the mining industry. One of the critical components in an excavator diesel engine is the connecting rod, which functions to transmit combustion forces from the piston to the crankshaft. This study aims to analyze the mechanism and causes of connecting rod failure in a 6-cylinder 350 HP excavator engine that experienced permanent deformation. The methods employed include visual observation, chemical composition testing, metallographic examination, Vickers hardness testing. Test results indicate that the connecting rod material conforms to OEM specifications, namely AISI 1548 steel with a ferrite-pearlite microstructure and an average hardness of 245 HV. However, maintenance history investigation revealed that overheating occurred, causing cylinder head gasket failure and liner deformation, which allowed coolant to enter the combustion chamber. This condition triggered the hydro lock phenomenon, generating extreme pressure that exceeded the connecting rod design capacity and resu

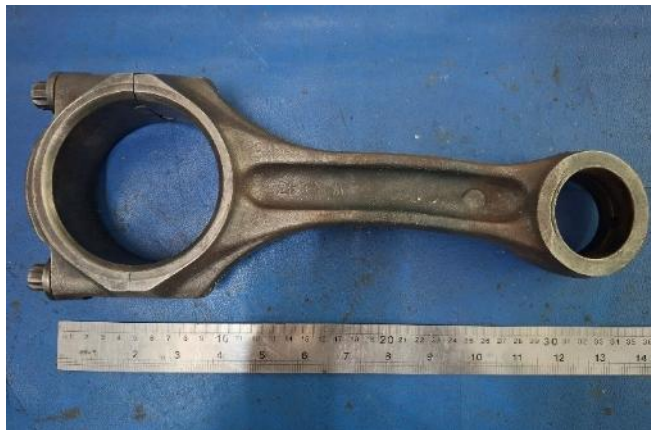
Figure 1: Connecting Rod

The connecting rod experienced failure as shown in Figure 1, exhibiting buckling with evidence of bending deformation at the shank area.

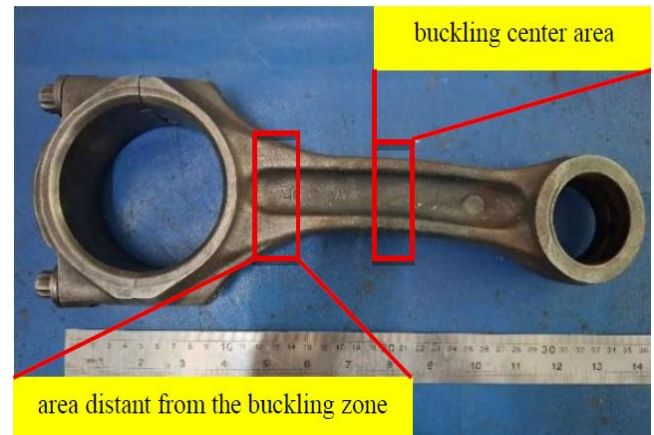
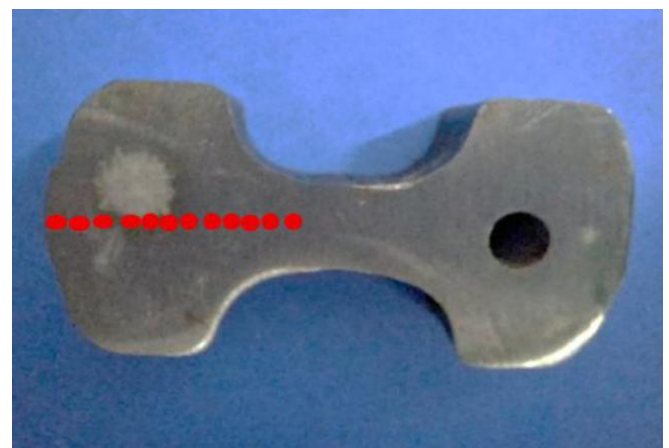
Figure 2: a) Sample cutting area for test specimen preparation b) Hardness test point locations from the surface to the center of the part

Hardness testing was conducted in accordance with ASTM E18. The test was performed by sectioning the buckling area, specifically at the region of maximum bending in the connecting rod. The testing equipment used was the Vickers hardness tester HMT-2000. Measurement points were taken starting from 0.5 mm from the outermost wall of the connecting rod cross-section to the central area, as illustrated in Figure 2.

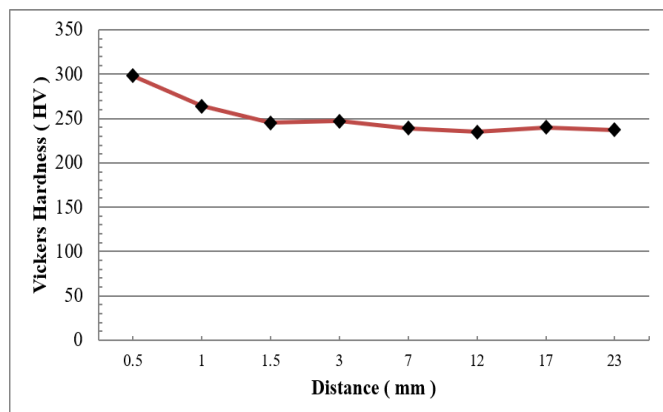
Figure 3: Hardness profile at the buckling area

Figures 3 and 4 present the hardness results of specimens at the buckling center and the area distant from the buckling zone, respectively. The results indicate that the hardness at the edge area is higher than at the interface and center regions, reaching 298 HV. The maximum hardness value for AISI 1548 material ranges between 230–270 HV thus, the hardness value at the buckling center exceeds this standard. This is attributed to plastic deformation at the outermost diameter of the material, which increased the local hardness value.

As reported in previous studies, the bending process causes an increase in hardness at the outer dimension area, with hardness values gradually approaching those of the original material toward the interior [10]. The localized increase in hardness observed at the outermost region of the buckling section also provides indirect evidence that the connecting rod experienced severe plastic deformation rather than thermal degradation. During hydro lock, the connecting rod is subjected to a compressive load exceeding its yield strength, causing localized plastic strain at the outer fibers where bending stress reaches its maximum.

The accumulation of plastic strain increases the dislocation density within the ferrite matrix, thereby restricting dislocation mobility and producing a strain-hardening effect. Consequently, the hardness increases significantly near the outer surface while gradually decreasing toward the neutral axis where plastic strain is minimal. This hardness gradient is characteristic of cold-worked steel subjected to bending deformation and confirms that the observed hardness increase is a consequence of overload-induced deformation instead of changes in chemical composition or heat treatment. Similar strain-hardening behavior has been reported for bent carbon steel components where the increase in Vickers hardness was directly correlated with local plastic strain and dislocation accumulation [10]. The hardness in areas distant from the buckling center remains within the standard range of 235–245 HV, as seen in Figure 3, and similarly the OEM connecting rod exhibits hardness values between 240–247 HV as shown in Figure 5.

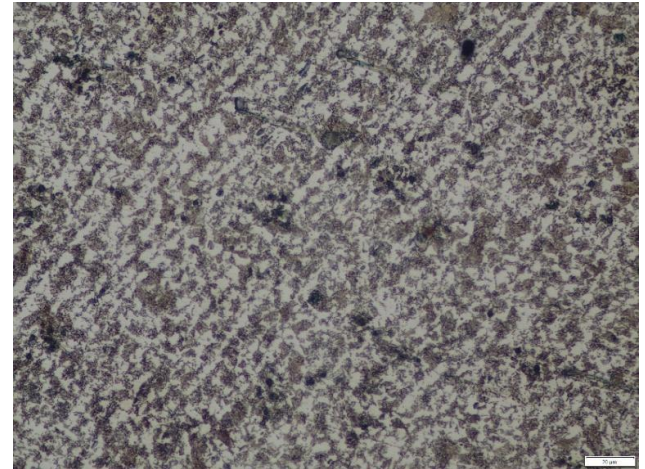
(b)

From the microstructure results in Figure 6b, it can be observed that at the outermost point (edge) of the buckling center, the microstructure has become flattened and elongated due to deformation caused by buckling. This is also consistent with findings from previous studies, which indicate that during the bending process, the microstructure at the outer side of the material becomes flatter compared to that of the center region [11], also shows the microstructure at the outer edge of the buckling region, where the connecting rod experienced the highest compressive-bending strain during the hydro lock event. The microstructure consists of ferrite (light phase) and pearlite (dark lamellar colonies), which is characteristic of normalized AISI 1548 medium-carbon steel. Compared with the undeformed region, both ferrite grains and pearlite colonies exhibit noticeable elongation and flattening along the deformation direction, indicating severe plastic deformation after the applied compressive stress exceeded the material yield strength.

This morphological change is attributed to the accumulation and movement of dislocations within the ferrite matrix, causing grains to elongate while pearlite colonies rotate and align parallel to the principal strain direction. Such grain distortion is a typical microstructural response during cold plastic deformation and bending, where the outermost fibers experience the maximum equivalent plastic strain. Importantly, no evidence of microcracks, intergranular fracture, carbide fragmentation, abnormal inclusions, or phase transformation was observed, indicating that the metallurgical integrity of the material remained intact despite the severe deformation. This observation confirms that the microstructural modification resulted from mechanical overload rather than manufacturing defects or improper heat treatment. Furthermore, the elongated ferrite–pearlite morphology is consistent with the localized hardness increase observed at the same region, since plastic deformation increases dislocation density and produces strain hardening, thereby increasing the resistance of the material to further plastic flow. Similar deformation-induced grain elongation and hardness enhancement in bent steel components have been reported by [10], while [11] demonstrated that the degree of grain distortion is directly associated with the distribution of plastic strain across the bent cross-section. These observations strongly support the conclusion that the connecting rod failure was governed by overload-induced plastic buckling caused by hydro lock rather than by metallurgical degradation.

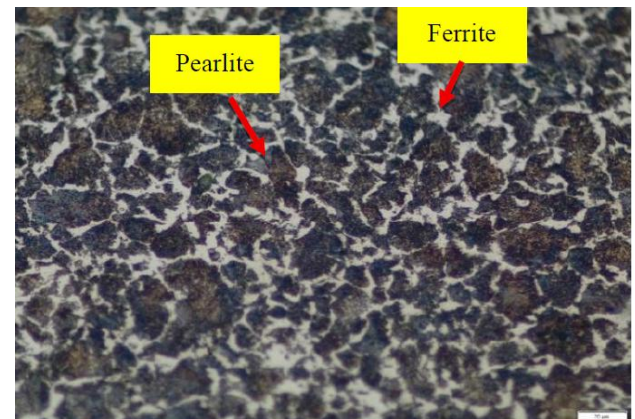
(c)

Figure 6c presents the microstructure observed at the center region of the connecting rod cross-section, corresponding to the neutral axis of the buckled section. The microstructure consists of a typical ferrite–pearlite structure, where ferrite appears as the bright phase and pearlite as the darker lamellar colonies. Unlike the edge region, no evidence of grain elongation or phase flattening is observed, indicating that this region did not experience significant plastic deformation during the buckling event. The ferrite grains retain their equiaxed morphology, while the pearlite colonies remain uniformly distributed with random orientation, suggesting that the original metallurgical structure was preserved. According to the mechanics of bending, the neutral axis undergoes negligible longitudinal strain, whereas the maximum tensile and compressive strains are concentrated at the outermost fibers of the cross-section. Consequently, the center region experiences only elastic deformation, resulting in minimal dislocation multiplication and no appreciable strain hardening or microstructural distortion. Furthermore, no metallurgical discontinuities such as microcracks, voids, carbide fragmentation, abnormal inclusions, or phase transformation were detected, confirming that the material maintained its metallurgical integrity throughout the loading

process. This observation is consistent with the hardness profile measured in the same region, where the hardness remained within the standard range for AISI 1548 steel (approximately 235–245 HV), indicating that the increase in hardness was localized only at the outer buckling surface. Similar microstructural behavior has been reported by [11], who demonstrated that deformation during bending is concentrated in the outer fibers, while the microstructure near the neutral axis remains essentially unchanged. Likewise, [10] showed that plastic strain and strain hardening decrease progressively from the outer surface toward the center of a bent steel section, producing a corresponding gradient in both microstructural deformation and hardness. Therefore, the preserved ferrite–pearlite morphology at the center region provides further evidence that the connecting rod failure resulted from localized overload-induced plastic buckling associated with the hydro lock phenomenon, rather than from intrinsic metallurgical defects or material degradation.
