# Analysis of Differences in Characteristics of *Coating* HVOF Based on Nickel and *Coating Plasma Spray* Based on Zirconia on Gas Turbine *Blades*

<sup>1\*</sup>Muchammad, <sup>2</sup>Budi Setiyana, <sup>3</sup>Puti Findyra Chaulia Karim

<sup>1,2,3</sup>Mechanical Engineering Department, Faculty of Engineering, Diponegoro University, Jl. Prof. H. Soedarto, SH, Tembalang-Semarang 50275, Indonesia

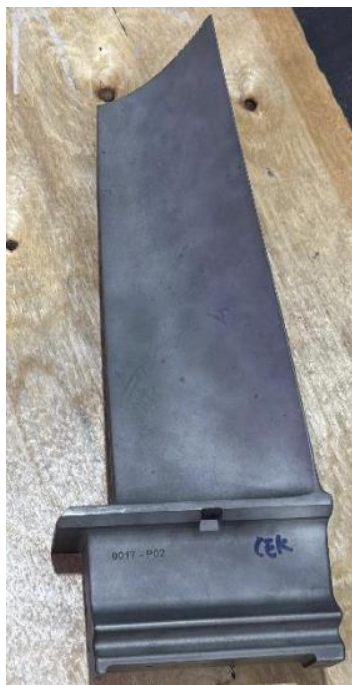
Figure 1: Gas turbine *blade* used as the observation object (PT PLN Nusantara Power UMRO JP-1, 2026)

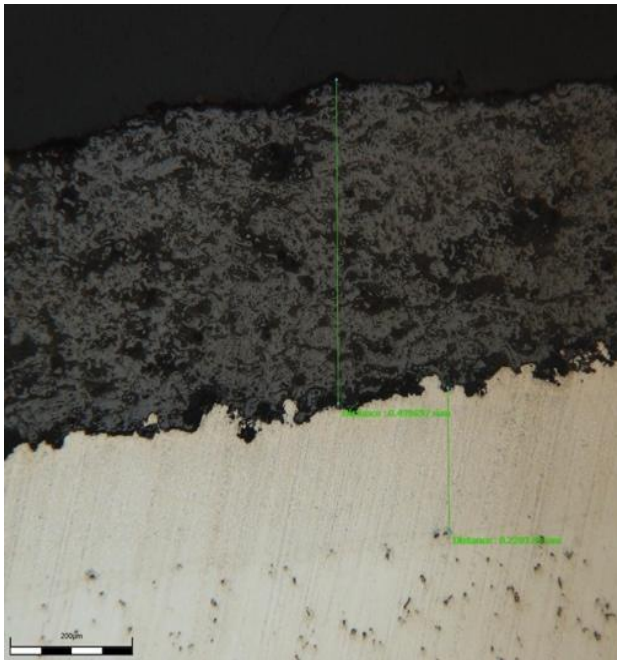
Figure 3: Coating microstructure before operation with a scale of 200 micrometers

The initial microstructure image showed three main parts, namely the *superalloy* substrate, nickel-based HVOF *coating*, and zirconia-based *plasma spray coating*. The HVOF layer was located between the substrate and the zirconia layer. Its shape was denser and relatively homogeneous, while the *plasma spray* layer on the outermost part appeared rougher, porous, and *lamellar* in structure.

The thickness of the zirconia-based *plasma spray coating* in the initial condition was recorded at around 0,499 mm. This value shows the function of the layer as a *top coat* that resists heat from combustion gases. The nickel-based HVOF layer had a thickness of around 0,220 mm and served as a *bond coat*. Its position between the substrate and zirconia is important to increase adhesion, resist oxidation, and reduce the risk of ceramic layer detachment.

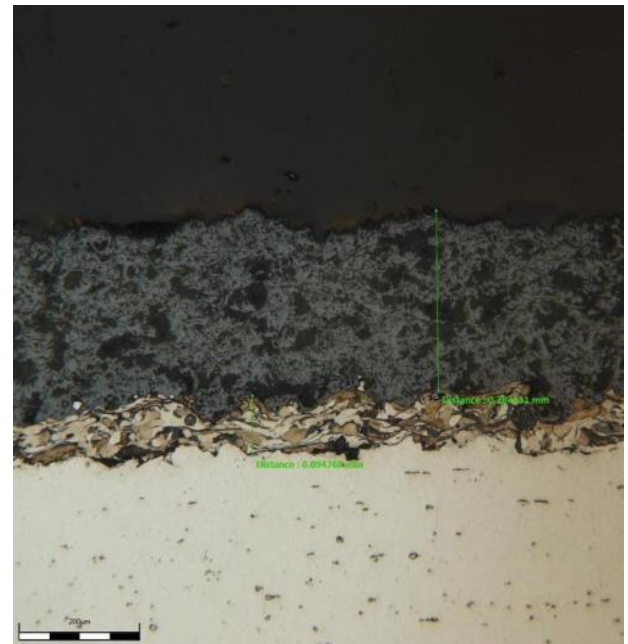
Figure 4: Coating microstructure after operation with a scale of 200 micrometers

The post-operational image showed clear changes in both layers. The thickness of the *plasma spray coating* decreased to around 0,284 mm, while the thickness of nickel-based HVOF decreased to around 0,094 mm. In addition to thickness reduction, microcracks, color changes in the *interface* area, indications of oxidation, and local separation between layers were observed.

The reduction in thickness indicates that the layer experienced material loss during operation. The causes may come from a combination of high-temperature exposure, hot gas flow, oxidation, and repeated thermal stress. The easiest change to see was in the outer layer because the *top coat* was the first part facing the operating environment.

Microcracks were mainly visible in the zirconia layer, which had higher porosity. This type of crack can form due to repeated thermal stress, especially when the temperature rises and falls during operation. Differences in the thermal expansion coefficient among the metal substrate, nickel *bond coat*, and ceramic *top coat* increase the possibility of internal stress formation. Oxidation in the *interface* area can also weaken bonding because oxide layer growth adds local stress and encourages delamination.

Indications of delamination need attention because layers that begin to separate can develop into *spallation* in the next cycle. When the *top coat* is lifted, heat and oxygen more easily reach the *bond coat*. This condition accelerates the formation of *Thermally Grown Oxide*, reduces adhesion, and decreases the ability of the *coating* to withstand high temperatures.

The thickness changes can be summarized as follows: the zirconia-based *plasma spray coating* changed from 0,499 mm to 0,284 mm, while the nickel-based HVOF changed from 0,220 mm to 0,094 mm. These figures show that both layers not only experienced morphological changes, but also lost part of their protective material after receiving operational exposure.

*Re-coating* should be considered before the protective layer loses its main function. When the *plasma spray* becomes thinner and more porous, thermal protection decreases. When HVOF becomes thinner, *top coat* adhesion and oxidation resistance also weaken. Maintenance decisions need to view both layers together, not only one layer.
