# Failure Analysis of Power Steering Gearbox Housing in 2500 CC Diesel Car

**Abstract** - The power steering gearbox housing is one of the components in a car that functions as a coupling and directional force converter between the steering wheel and the front wheels of the car. This component experienced failure in the form of fracture. This study aims to determine the failure mechanism, material characteristics, and loading mechanism through failure analysis. The testing methods used were visual observation, chemical composition testing, metallographic testing, hardness testing, and Finite Element Method (FEM) simulation using SOLIDWORKS 2025 software. Visual observation results show that the failure that occurred led to the phenomenon of fatigue failure, which is characterized by crack initiation, final crack zone, and ratchet marks. Metallographic testing shows that the material has nodular graphite with a ferrite + pearlite matrix, indicating that the material is nodular cast iron. Hardness testing showed a value of 194-221 HV. Composition testing revealed the presence of nodulizer components, namely Mg and Ce. The FEM simulation results show that the peak stress for the 4-bo

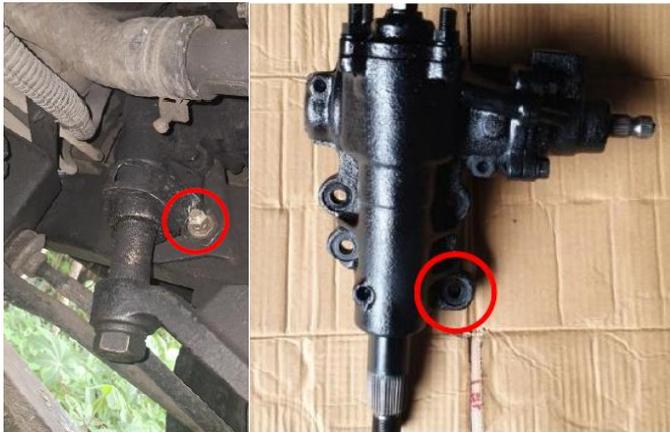
Figure 1: Power steering gearbox housing specimen

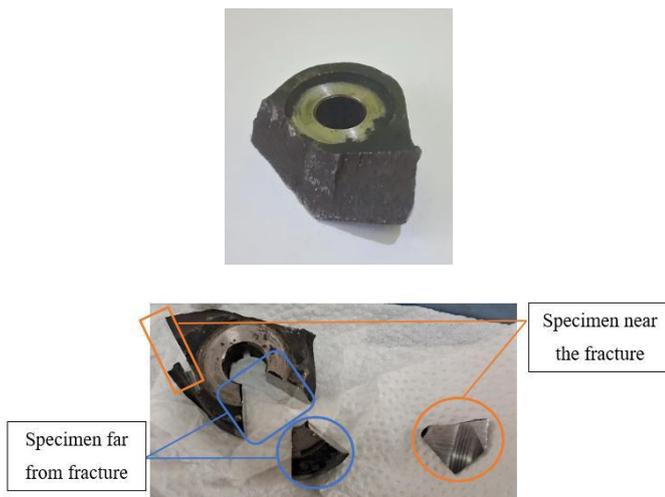
Figure 2: Results of cutting and specimen collection on small fractures in the gearbox housing using an EDM Wire Cutting Machine

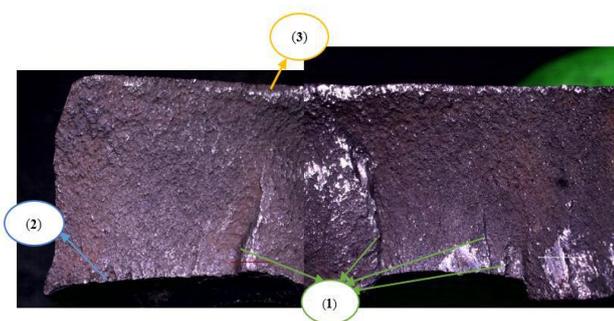
Figure 3: Observation using a 6.7x magnification macrographic microscope on the surface of the housing fracture, (1) Indication of ratchet marks, (2) Indication of crack initiation, (3) Final crack zone

Based on visual observations made on the surface of the power steering gearbox housing fracture, it can be seen that the fracture surface appears irregular, similar to gravel, with many small protrusions and holes as can be seen in Figure 3. There are indications of ratchet marks from several points on the fracture surface, indicating the presence of a fatigue mechanism with several initiation points. The crack started from the fillet on the inner side of the housing and spread to

the final crack zone on the surface of the housing that was in direct contact with the frame. On the other hand, material fatigue characteristics such as river marks, radial lines, chevrons, striations, and beach marks were not clearly visible in the fractography.

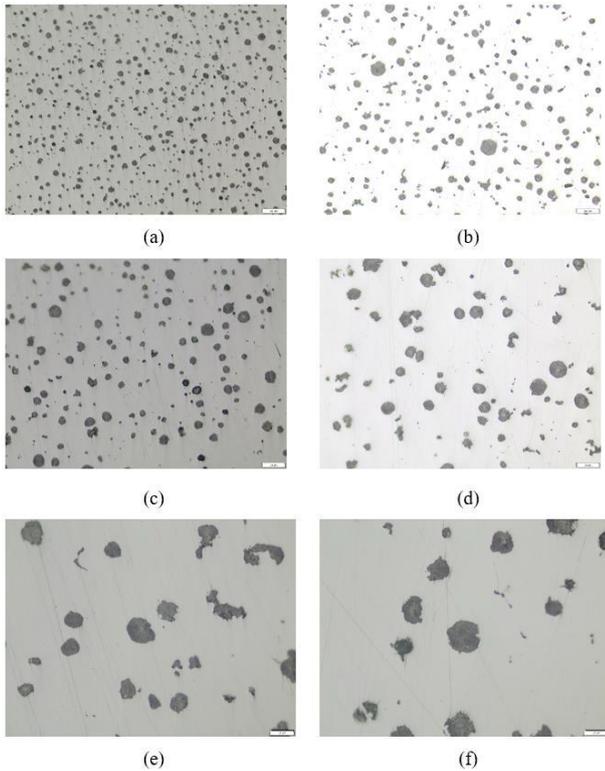
Metallographic testing results show that nodular graphite particles can be seen as dark, round particles with smooth edges scattered across the entire surface. Graphite nodules

have a spheroidal or circular shape, which is the main characteristic of nodular cast iron. In the far part of the fracture, the nodules are more evenly distributed and have a more rounded shape than in the part near the fracture, as can be seen in Figure 5.

**Figure 5: Non-etched photo results, (a) Housing far from the fracture at 100x magnification, (b) Housing near the fracture at 100x magnification, (c) Housing far from the fracture at 200x magnification, (d) Housing near the fracture at 200x magnification, (e) Housing far from the fracture at 500x magnification, (f) Housing near the fracture at 500x magnification**

The nodules have a slightly rougher shape and are not as dense near the fracture, which can cause stress concentration during component use, resulting in component weakening in that area. This can increase the likelihood of fatigue crack initiation under cyclic loading conditions [7]. The metal matrix surrounding the graphite nodules consists of a combination of ferrite (light areas) and pearlite (dark areas) [8]. The presence of ferrite with a bull's-eye structure surrounding nodular graphite, both of which are also found in the pearlite matrix, indicates that the test material is grade 80-55-06 nodular cast iron. Figure 6 shows a comparison of the 200x magnification sample photo with a photo from the Microstructure Atlas of Grade 80-55-06 pearlitic ductile iron.

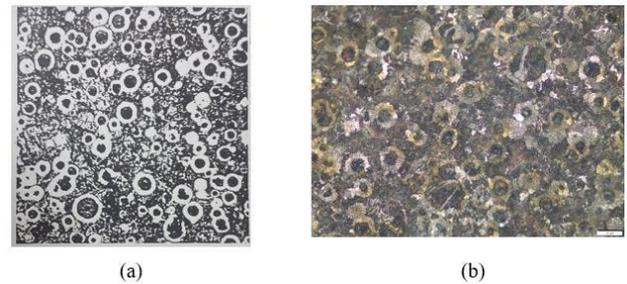
**Figure 6: Comparison of results with the Microstructure Atlas (a) NCI grade 80-55-06 Microstructure Atlas [9] (b) 200x magnification photo of housing results**

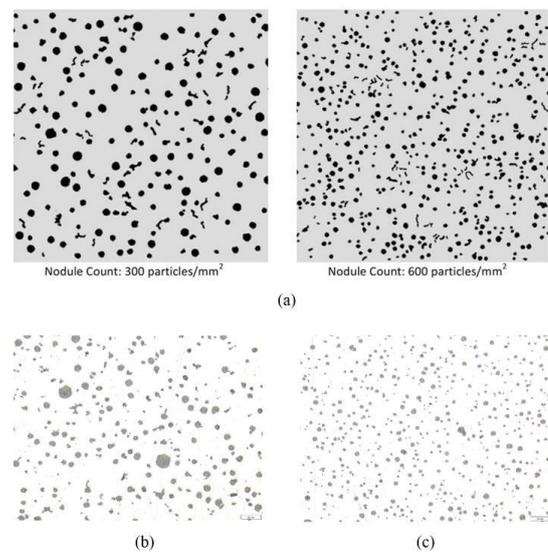
**Figure 7: Comparison of nodule density with ASTM A247, (a) Nodule density for 90% nodularity ductile iron at 100x magnification [10] (b) Housing near fracture at 100x magnification, (c) Housing far from fracture at 100x magnification**

Based on ASTM A247, the material for this power steering gearbox housing is classified as type 1 nodular graphite with 90% nodularity and a nodule density value of approximately 600 particles/mm<sup>2</sup> (class 7) for the far end of the fracture and 300 particles/mm<sup>2</sup> (class 6) for the near end of the fracture. A comparison of nodule density between specimens and ASTM A247 can be seen in Figure 7.

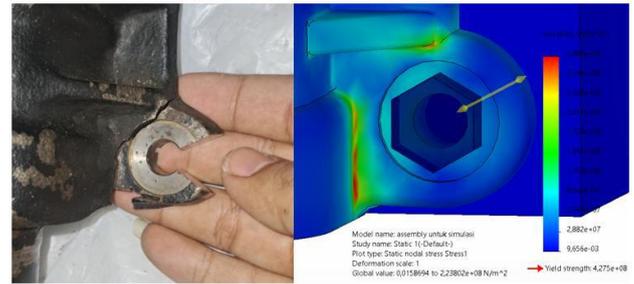
From the simulation results with a load input of 3377 N in the pitman arm direction, the housing experienced a bending moment that caused stress concentration at two points (at the location of the fracture), which was indicated by a difference in color contour in that area. A comparison between the simulation results and the location of the specimen fracture can be seen in Figure 8.

**Figure 8: Comparison of sample fracture locations with simulation results**

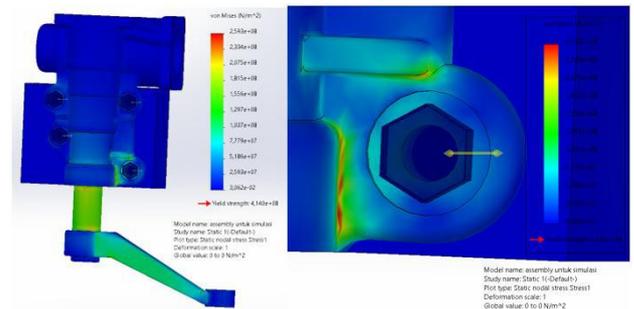
**Figure 9: Finite Element Methods simulation results for a 4-bolt gearbox housing with forces acting away from the frame**

Finite element simulation with 4 bolts and the force direction away from the frame shows that the peak Von Mises stress is 259.3 MPa, which is seen in the fillet area at the same location where the fracture on the specimen occurred, as shown in Figure 9. The estimated tensile strength value of the material based on the hardness test is 654 MPa. Meanwhile, the tensile strength value of the material from the literature is 696.37 MPa. The conservative industry estimate of the fatigue margin for ductile iron is 40% of the ultimate tensile strength value, which is 261.6 MPa for the tested material and 278.5 MPa for the material from the literature. This indicates that the model is still within the safe range because the peak stress has a lower value than the material fatigue margin.

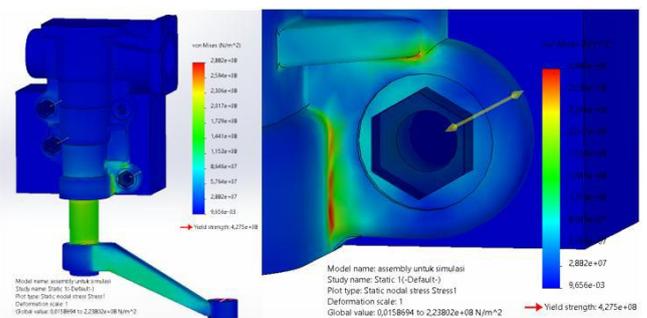
**Figure 10: Finite Element Methods simulation results for a 3-bolt gearbox housing with forces acting away from the frame**

Figure 10 shows a simulation with three bolts and the direction of force away from the frame. The result is that the

Von Mises peak stress increases to 288.2 MPa. This indicates that this model is unsafe because the peak stress has a higher value than the fatigue margin of both the tested material (261.6 MPa) and the material from the literature (278.5 MPa). Higher stress significantly increases the risk of fatigue crack initiation and rapid propagation. This may explain why the component failed after a relatively long service life (23 years).
