# Analysis of Tool Failure in Stainless Steel Pipe Notching Using Bi-Metal Hole Saw under Manual Operation

<sup>1,2,3</sup>Mechanical Engineering, Diponegoro University, Semarang, Indonesia

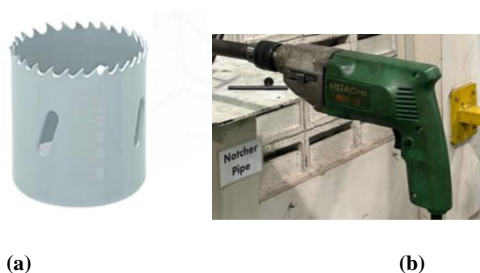
Figure 1: Stainless steel pipe material

The pipe notching process was carried out using a manual pipe notching machine driven by a Hitachi DUT-13 hand drill, a 600 W heavy-duty electric drill designed for metalworking applications. The tool features a chuck capacity of 1.5–13 mm, a no-load speed of up to 1,800 RPM, and a weight of approximately 2.2 kg. The cutting tool used was a bi-metal hole saw with a diameter of 33 mm. The workpiece material was a stainless steel pipe with a diameter of 1 inch and a wall thickness of 3.35 mm. The equipment and materials used in this study are shown in Figures 1 to 3.

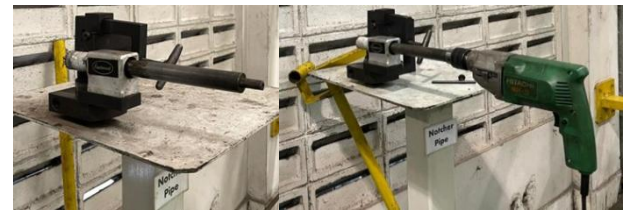
Figure 2: Bi-metal hole saw cutting tool (a) and Hitachi DUT-13 hand drill as the notching machine drive unit (b)

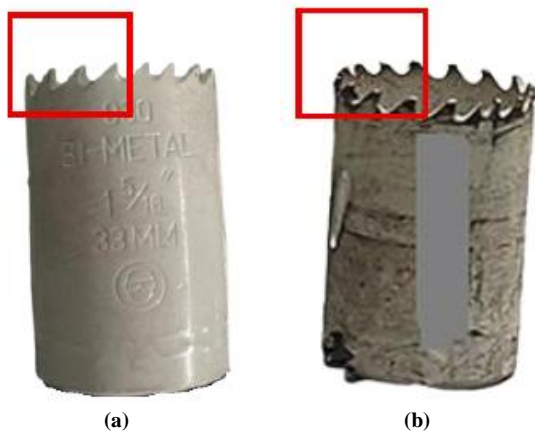
Figure 4: New hole saw with sharp cutting teeth (a) and used hole saw showing wear on the cutting teeth (b)

Field observations indicate that the cutting tool experienced a progressive degradation in performance during the notching process. In the initial stage, the cutting operation proceeded stably and produced the intended geometry. The cutting tool maintained good sharpness, and the cutting force remained relatively low.

As the duration of use increased, the cutting resistance also increased. The operator reported a higher load during operation, indicating a decline in tool performance. In the subsequent stage, a significant reduction in cutting edge sharpness was observed. Cutting time increased, and product quality gradually deteriorated. Geometric deviations began to appear in the notched results. The operator applied additional force to maintain the cutting process, which in turn accelerated tool degradation. Visual inspection of the used tool revealed noticeable changes in tooth geometry. These changes indicate the presence of combined and complex wear mechanisms. The observed changes in the hole saw are shown in Figure 4, while defective products caused by tool wear are presented in Figure 5.

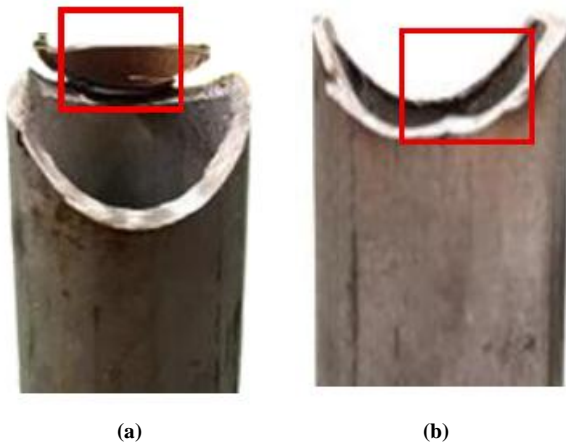
Figure 5: Incompletely cut product (a) and product with out-of-standard profile (b)

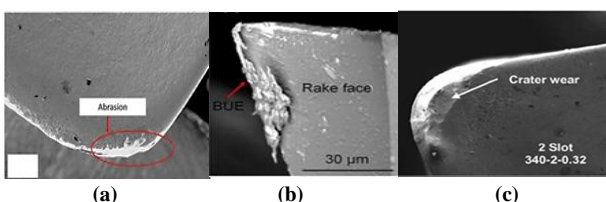
Figure 6: Tool wear mechanisms including abrasive wear (a), adhesive wear (b), and thermal degradation(c), adapted from the literature [5–7]

The theoretical analysis indicates that cutting tool wear involves three primary mechanisms, namely abrasive wear, adhesive wear, and thermal degradation. These mechanisms act simultaneously during the cutting process, contributing collectively to tool deterioration. The combined wear mechanisms are illustrated in Figure 6, while Figure 7 presents the resulting consequences on the product due to tool wear. Furthermore, Figure 8 provides a conceptual illustration of how these wear mechanisms may develop during operation.

Abrasive wear occurs due to the interaction between the cutting tool surface and hard particles from the stainless steel material. The work hardening phenomenon increases the surface hardness of the material. This hardened surface acts as an abrasive agent that progressively wears the cutting tool.

Adhesive wear occurs as a result of direct contact between the cutting tool and the workpiece material at elevated temperatures. Stainless steel adheres to the tool surface, leading to the formation of a built-up edge. This structure is unstable and interferes with the cutting process.

Thermal degradation is identified as the most dominant mechanism in this process. High temperatures reduce the hardness of the cutting tool material, causing a loss of its ability to maintain sharpness. The thermal degradation mechanism is associated with elevated cutting temperatures that lead to reduced tool hardness, surface oxidation, and the potential formation of micro-cracks due to thermal loading.

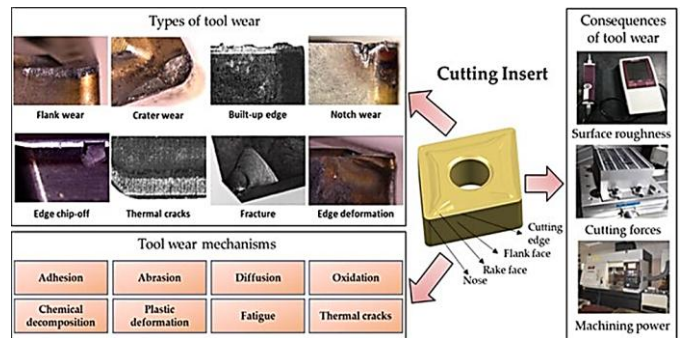
Figure 7: Types of tool wear and wear mechanisms [8]

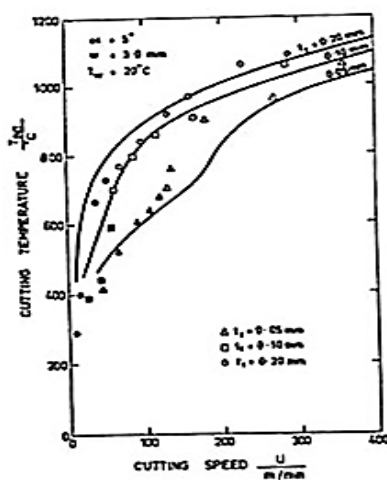
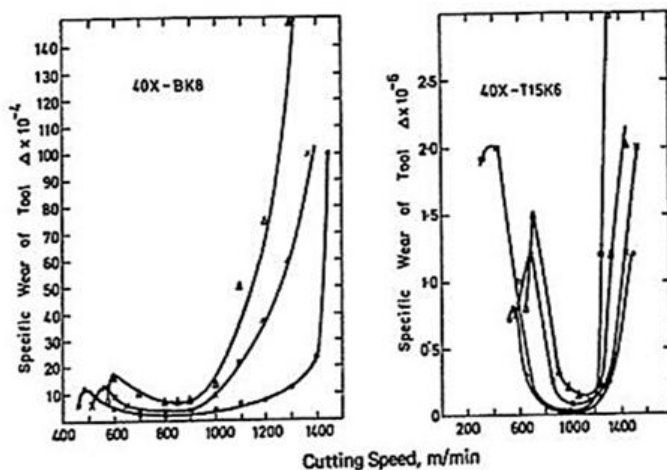
Figure 9: The example of the relationship between cutting speed, cutting temperature (a) and specific wear of tool (b) [10, 11]

The demand for higher productivity and excellent surface integrity of machined components leads to concentrated heat generation in the cutting zone, which is detrimental to the effective service life of the cutting tool. Although cutting temperature generally increases proportionally with cutting speed, specific tool wear behavior indicates the existence of an

optimum low cutting temperature between mechanically induced wear and thermally induced wear, as illustrated in Figure 9.

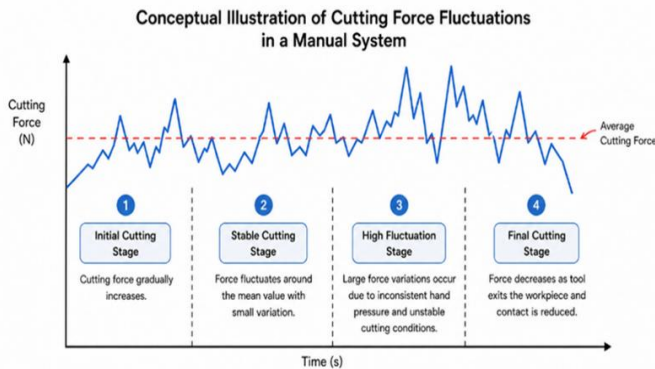
Figure 10: Conceptual illustration of cutting force fluctuations in a manual machining system

In summary, the conceptual illustration presented in Figures 10 and 11 indicates the need for a transition from manual systems to automated machining systems (such as CNC or auto-feed mechanisms) to ensure constant cutting force, improve product quality, and extend tool life.

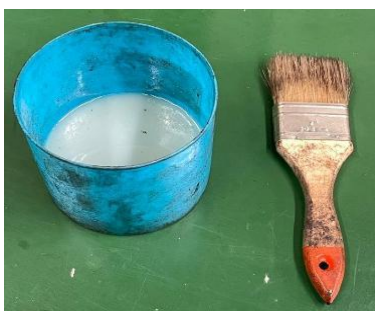
Figure 12: Cutting fluid applied manually using a brush

The cooling system in the cutting process is applied manually and in a non-continuous manner [1,14]. The operator intermittently applies the coolant during machining. This application pattern results in non-uniform cooling distribution in the cutting zone [1,15]. Figure 12 shows the cutting fluid and brush used to cool the cutting process.

Unstable cooling conditions make it difficult to control the temperature in the cutting zone. The temperature tends to increase as the cutting process progresses. This heat accumulation accelerates cutting tool degradation [14,17–19].

The manual cooling system has several main limitations. Cooling distribution is not uniform across the entire contact area between the cutting tool and the workpiece. The system is unable to maintain a stable temperature throughout the machining process. In addition, dependence on the operator makes cooling consistency difficult to achieve [14,16].

The cooling system should be improved to reduce heat accumulation. The use of more controlled cooling methods can extend cutting tool life [1,14,15]. An improved cooling system also contributes to better machining quality [1,16].
