# Material Characterization of Diesel Engine Connecting Rod Excavator 6 Cylinder 350 HP

**Abstract** - Component failures in heavy equipment engines can cause significant operational losses, particularly in the mining industry. One of the critical components in an excavator diesel engine is the connecting rod, which functions to transmit combustion forces from the piston to the crankshaft. This study aims to analyze the mechanism and causes of connecting rod failure in a 6-cylinder 350 HP excavator engine that experienced permanent deformation. The methods employed include visual observation, chemical composition testing, metallographic examination, Vickers hardness testing. Test results indicate that the connecting rod material conforms to OEM specifications, namely AISI 1548 steel with a ferrite-pearlite microstructure and an average hardness of 245 HV. However, maintenance history investigation revealed that overheating occurred, causing cylinder head gasket failure and liner deformation, which allowed coolant to enter the combustion chamber. This condition triggered the hydro lock phenomenon, generating extreme pressure that exceeded the connecting rod design capacity and resu

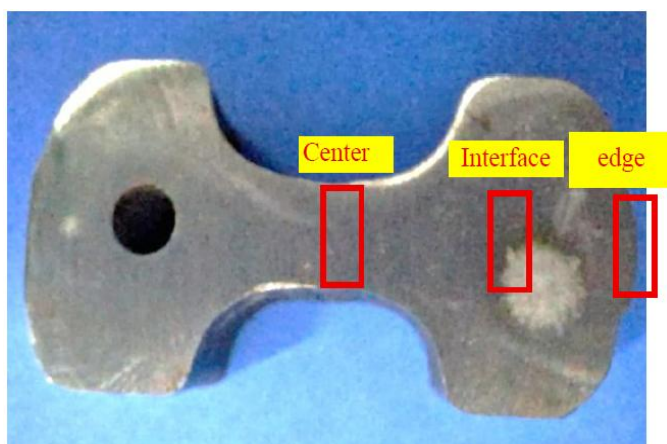
(a)

Microstructure examination using the Olympus BX41M optical microscope reveals that the connecting rod material consists of ferrite and pearlite phases, which is consistent with the characteristics of AISI 1548 material, as shown in Figure 6.

Figure 6: a) Microstructure sampling area b) Microstructure at the edge area at 500X magnification c) Microstructure at the interface and center area at 500X magnification
