# Failure Analysis of Power Steering Gearbox Housing in 2500 CC Diesel Car

**Abstract** - The power steering gearbox housing is one of the components in a car that functions as a coupling and directional force converter between the steering wheel and the front wheels of the car. This component experienced failure in the form of fracture. This study aims to determine the failure mechanism, material characteristics, and loading mechanism through failure analysis. The testing methods used were visual observation, chemical composition testing, metallographic testing, hardness testing, and Finite Element Method (FEM) simulation using SOLIDWORKS 2025 software. Visual observation results show that the failure that occurred led to the phenomenon of fatigue failure, which is characterized by crack initiation, final crack zone, and ratchet marks. Metallographic testing shows that the material has nodular graphite with a ferrite + pearlite matrix, indicating that the material is nodular cast iron. Hardness testing showed a value of 194-221 HV. Composition testing revealed the presence of nodulizer components, namely Mg and Ce. The FEM simulation results show that the peak stress for the 4-bo

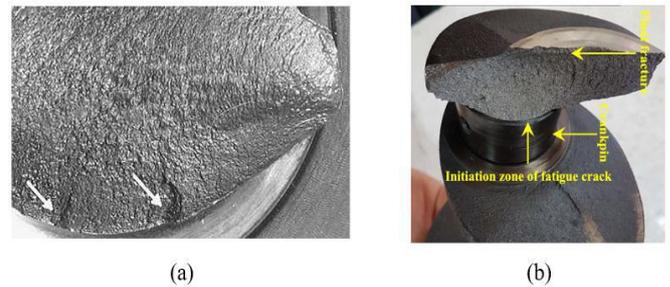
A comparison of the failure case with fatigue failure symptoms in nodular cast iron material is shown in Figure 4.

Figure 4: Cases of failure with symptoms of fatigue failure, (a) Indications of ratchet marks on the crankshaft due to fatigue failure [5], (b) Crack initiation and final crack zone on the truck crankshaft due to fatigue failure [6]
